## Technical Bulletin:

4 Post Sawmills - purchased since Oct.1, 2020

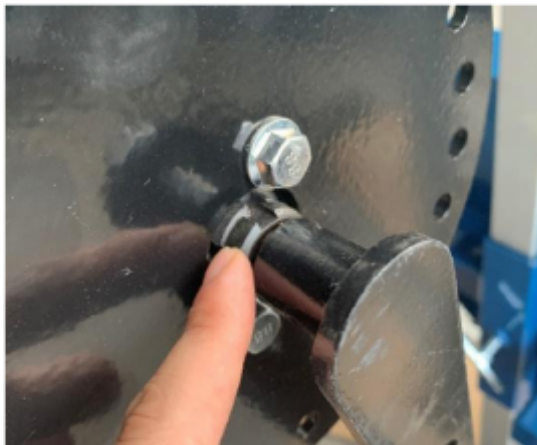
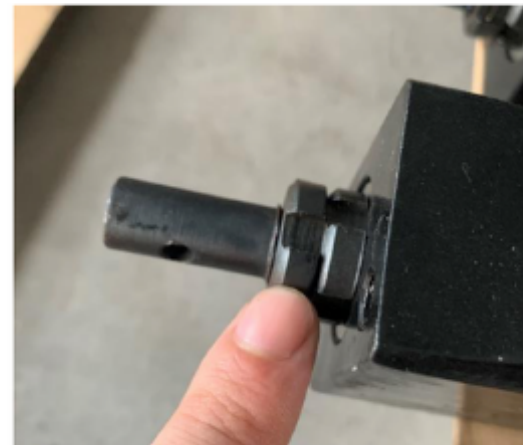
Some models have had the brass crank fitting wear prematurely.

This is due to it be overtightened at the manufacturer.

Fix: Before operating, check the round nut on the lift crank to make sure it is not over tightened. It should be just snug but not overly tight.

If you experience failure please contact your point of purchase for a replacement bushing.
